## ENVIRONMENTAL QUALITY AND CLIMATE RESILIENCE IN EAST, CONT.

### FLOOD PRONE AREAS

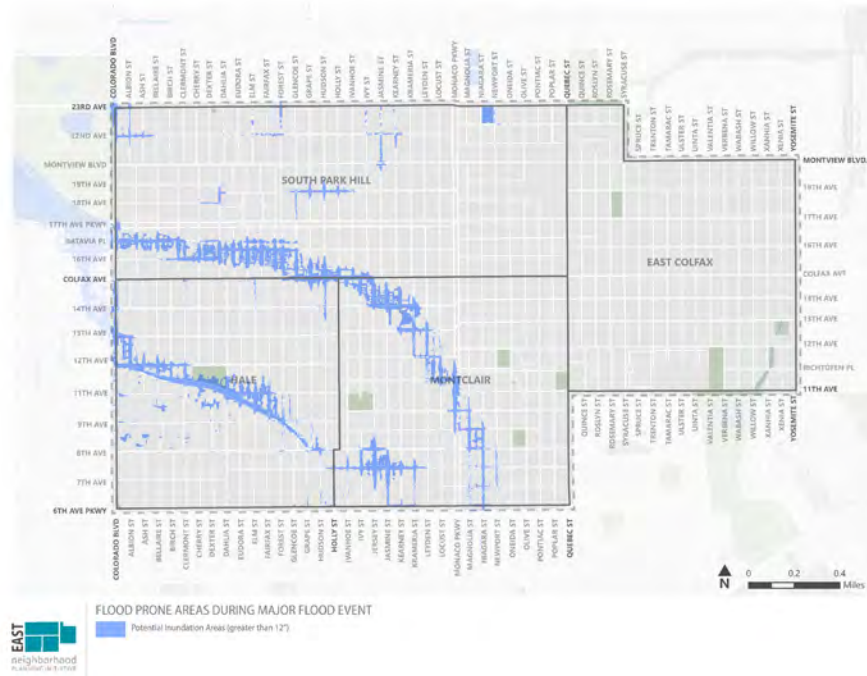
### FLOOD PRONE AREAS

Flood Prone Areas are a result of the natural terrain, undersized stormwater infrastructure system, increased impervious surface affecting stormwater runoff, and duration and intensity of a rain event. Potential inundation areas are the location where computer modeling predicts that stormwater runoff can accumulate in depths greater than what the streets are designed to handle during a major flood event.

The East Area has several low-lying areas, including along the alignment of the historic Montclair Creek, Colfax Avenue between the Mayfair Town Center and Dahlia Street, 14th Avenue and Kearney/Krameria Streets in the Mayfair Town Center area, Severn Place and Jersey Street, and 16th Avenue and Dahlia Street.
